FOCUS ON THE SAFE PLANT

Biogas plants should be safe to operate. In Germany, the owner is responsible whenever statutory regulations are violated. During inspections, experts regularly find defects and other weak spots under Section 29a BlmSchG which is Germany's Federal Pollution Control Act; Arrangement of safety tests for facilities. **By Thomas Gaul**

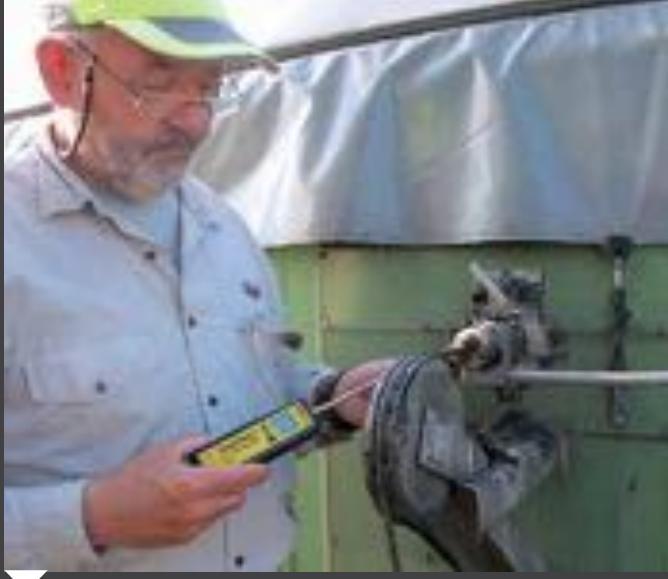
Gas leaks are a major issue in biogas plants. Leaks are not only dangerous (explosion hazard!), they are also detrimental to the environment – and they cost the owners money. So they should absolutely be avoided. "Sources of loss" are, in particular, the foil roofs of digesters and postdigesters. They should regularly be inspected for leaks. This can be done by a gas cam or a handy measuring gauge.

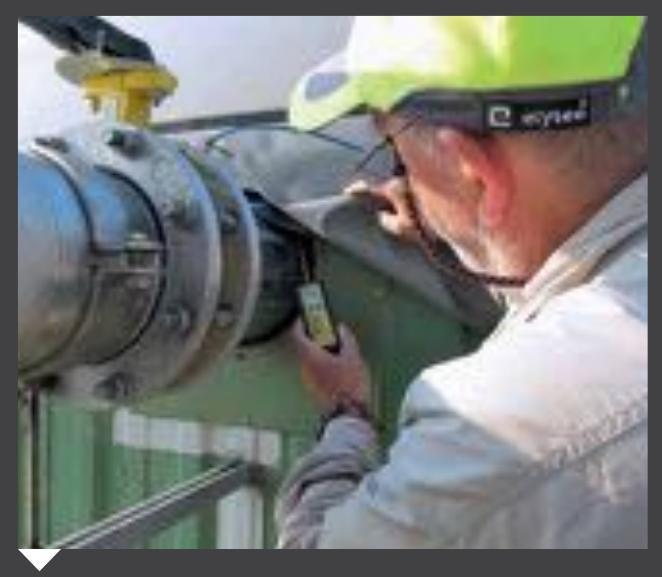
The rope leadthroughs should be inspected. Are they moving easily, and is there a suffiient supply of lubricant? Gas leaks are also possible at rope leadthroughs.

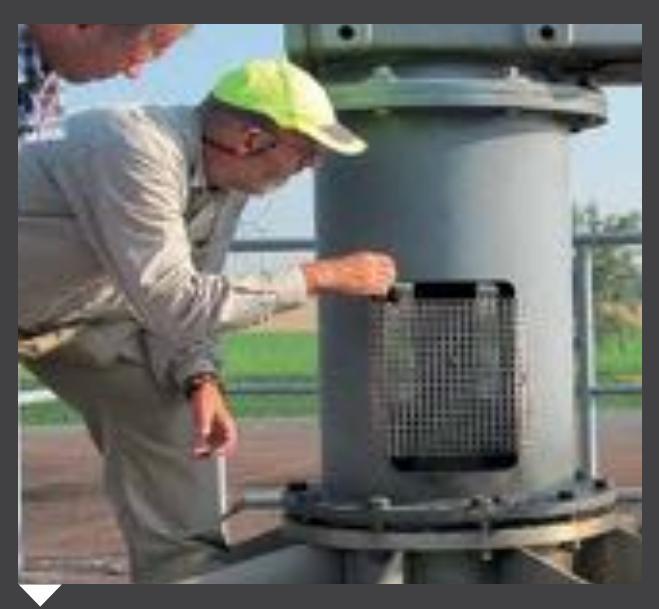
Pipe leadthroughs and connections are potential sources of leaks. Gas losses due to leaks can add up to a total of 1,000.00 euro a year in a 500 kW plant. The investment in a gas meter will be recovered quickly.

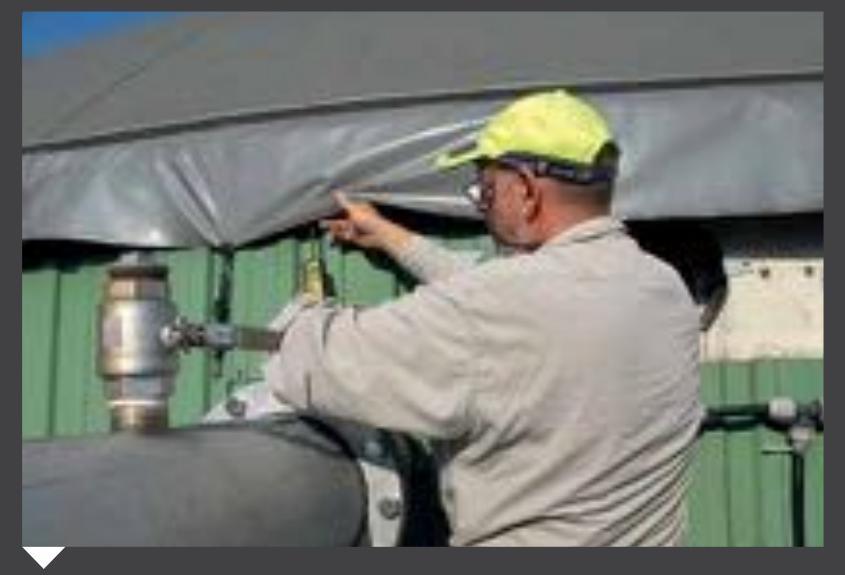
The cords on the foil roof are exposed to particular wear and tear due to wind and weather, and should therefore be inspected regularly.

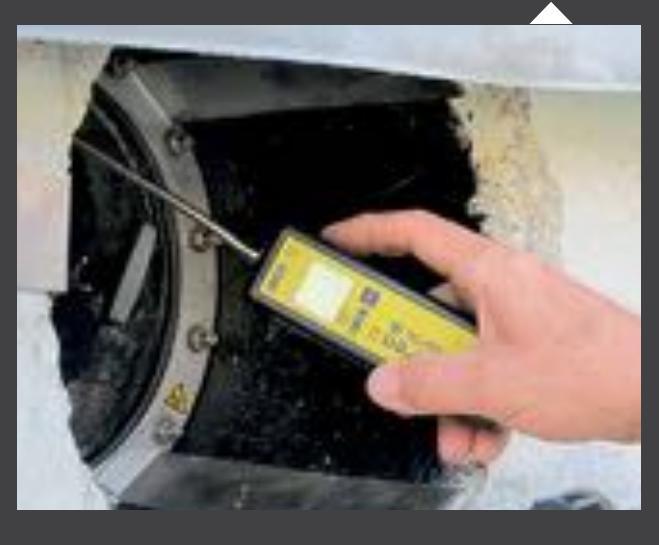
The point at which the agitator enters the digester should be inspected for leaks. The ventilation should also not be bypassed but checked.

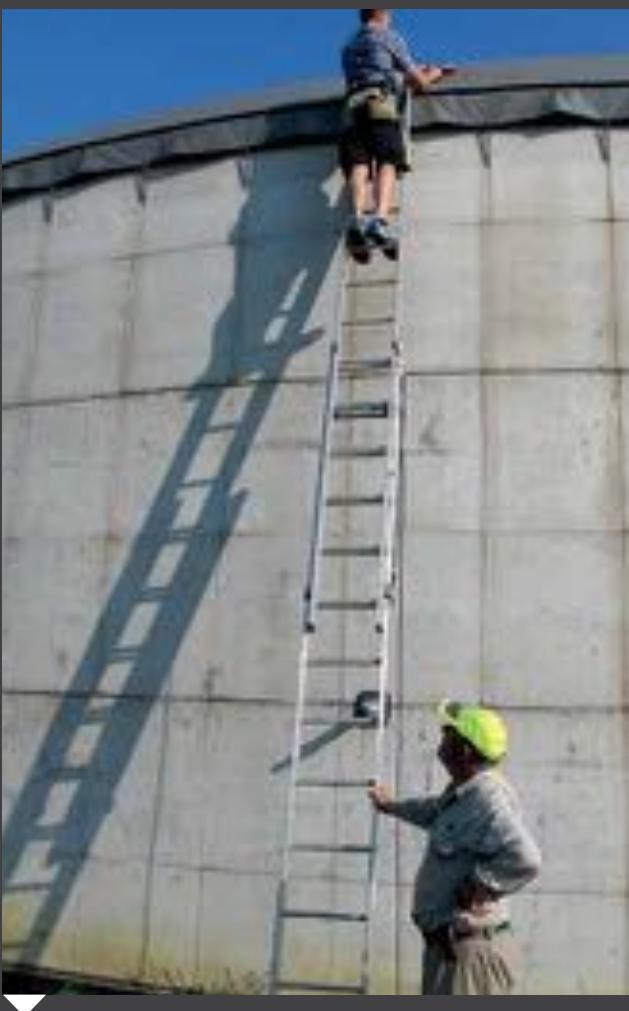
A stable ladder is a precondition for carrying out work at a height. Some plant manufacturers offer a platform as a kind of gangway around the plant. A work platform at a telescopic loader is an alternative. This is good provided access to the vessel is possible from all sides.

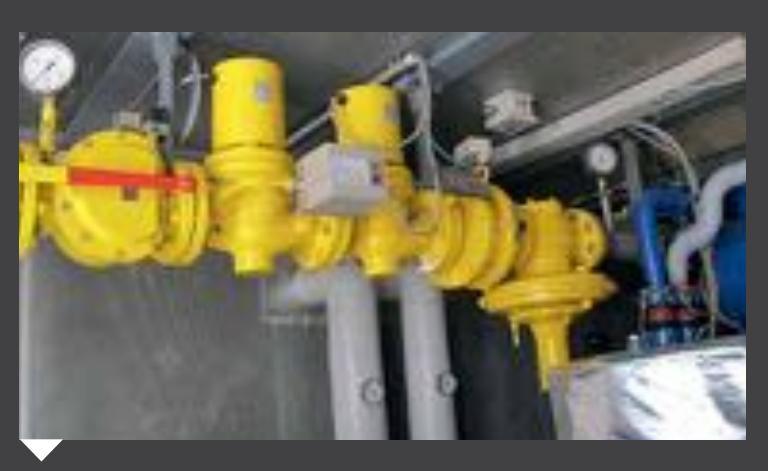
The ventilation of the cogeneration container is very important to prevent overheating and fire.

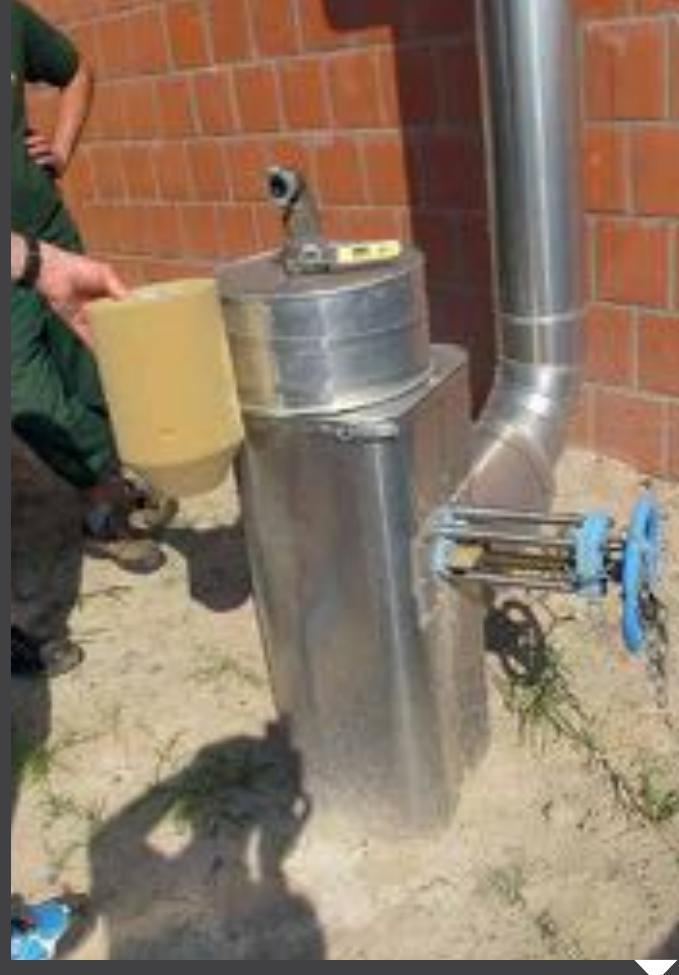
Such a "go-devil" is a tool to clean the pipelines from time to time.
